Advisory Region Northern Gallatin

Northern Gallatin, 2017-03-31

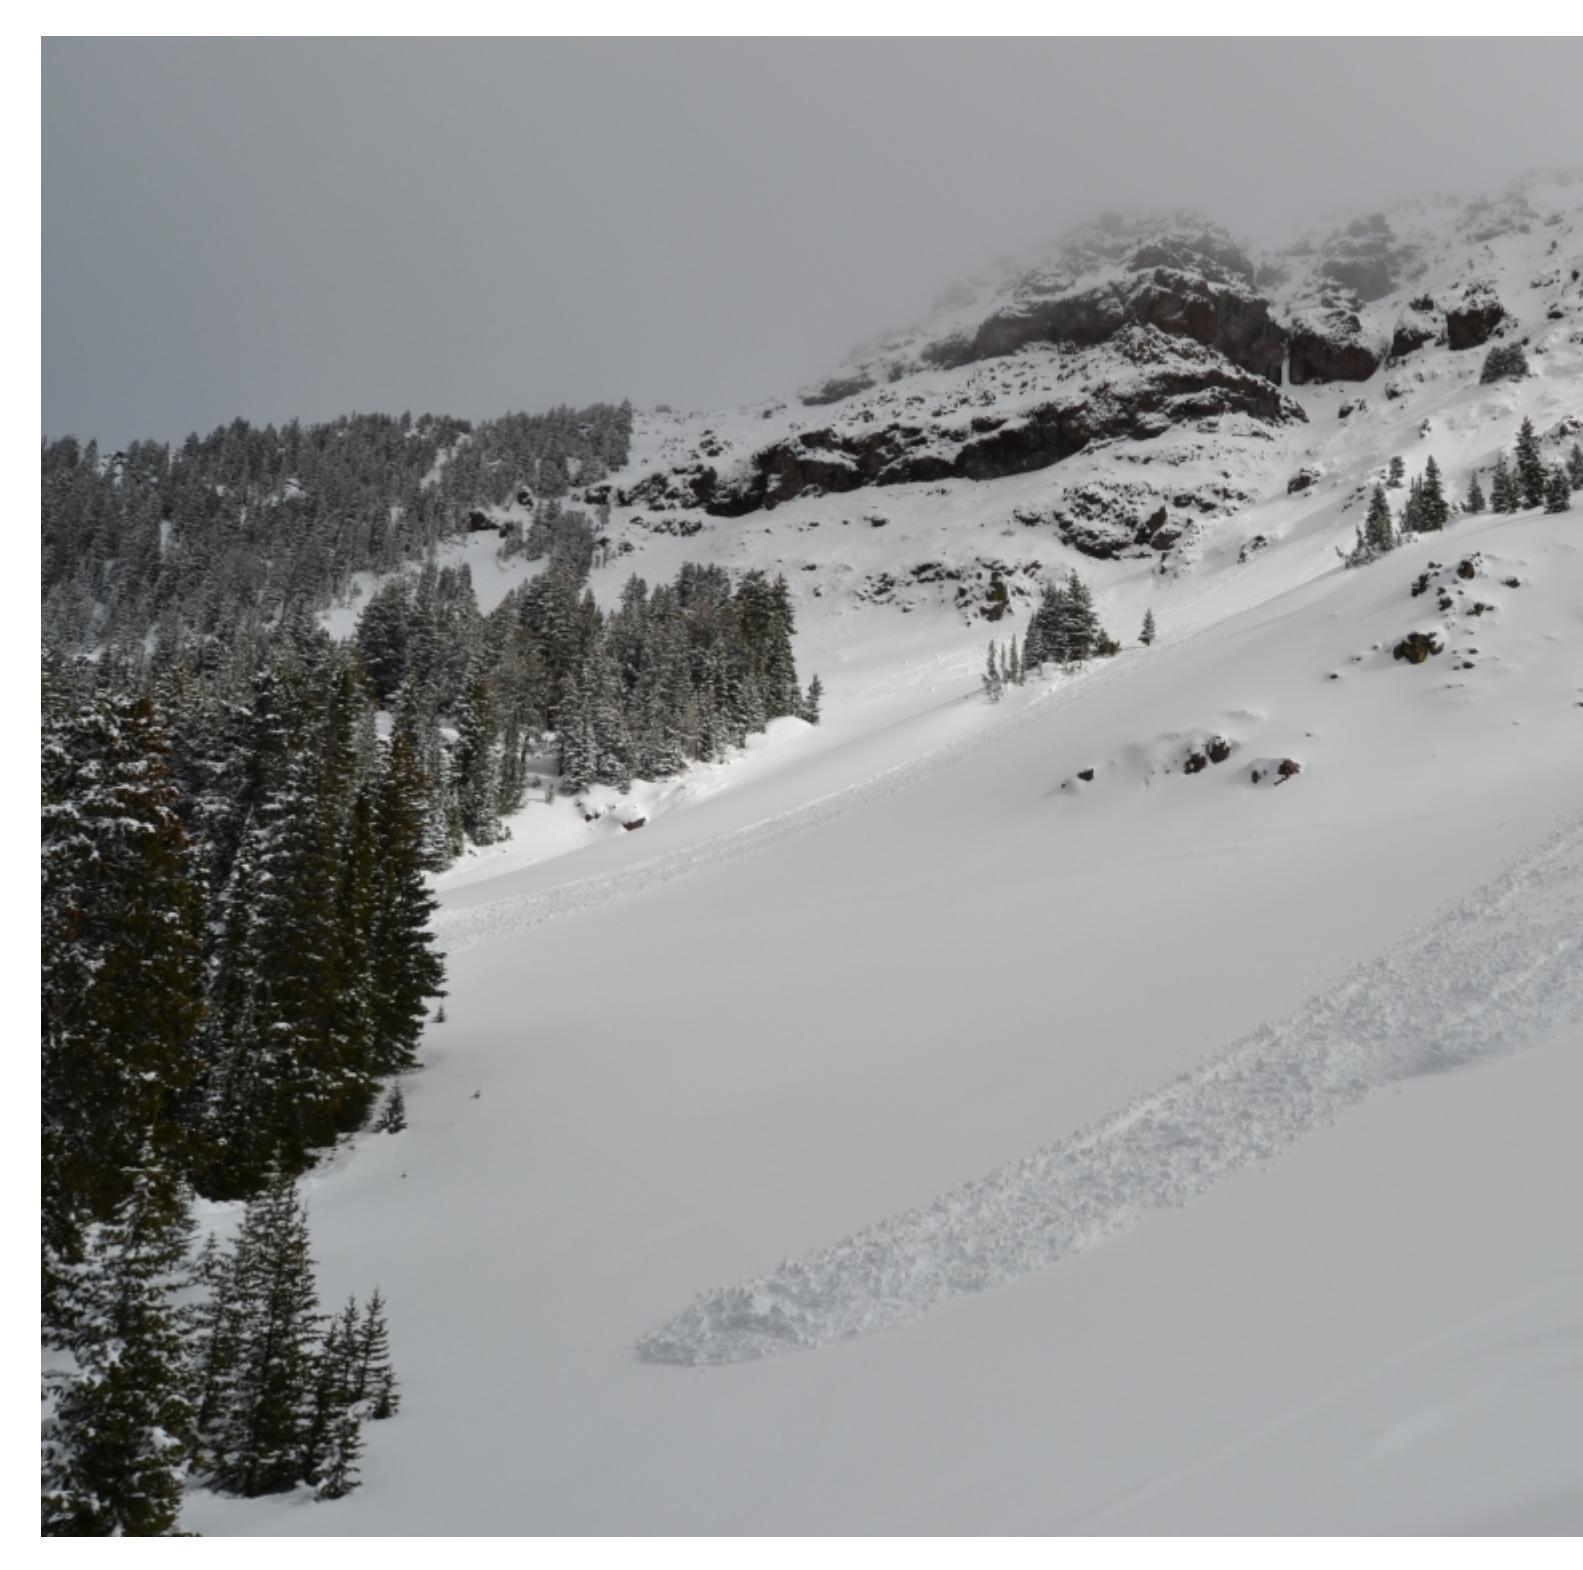
A skier on Mt Blackmore in the northern Gallatin Range observed multiple dry loose avalnaches in steep terrain. These slides were the result of nearly a foot of snow sliding a firm ice crust. Photo B. Vandenbos
